Manhole Inspection Summary

Manhole # S57E__005MH

Insp Date: **7/1/08 9:26 AM**

Location Address: **4401 e lombard st**

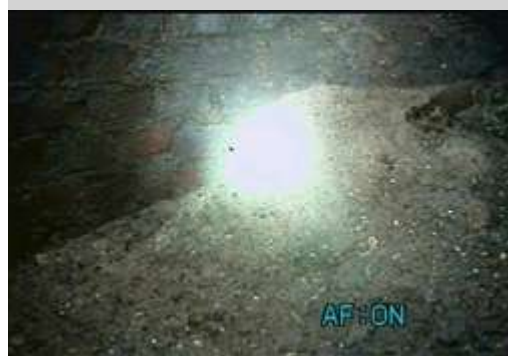
Defect 4

Condition: ☐ Sound ☐ Cracked ☐ Root Intrusion ☐ Deteriorated ☐ Leaks ☒ Debris

channel debris

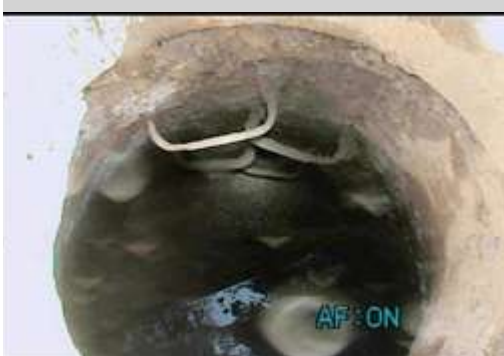
Defect 2

bench debris

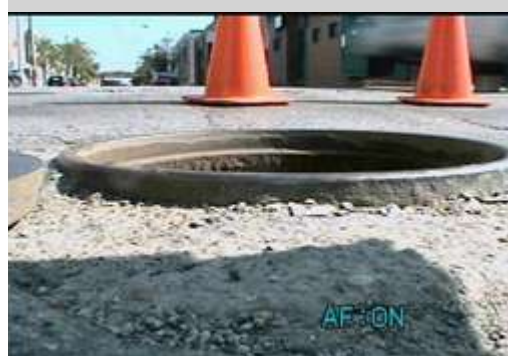
Defect 1

Count: **4** Missing: **0** ☒ Corroded

corroded steps

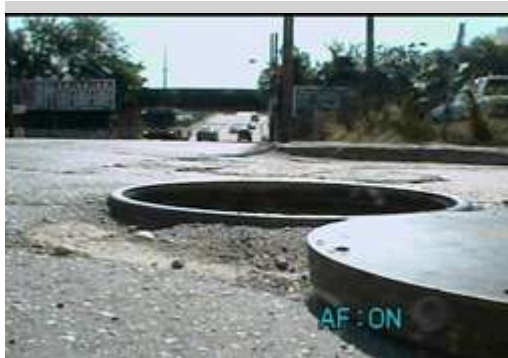
Defect

Diameter: **26** (in.) Length: **0** (in.) Dist A/B Grade: **2** (in.)

above grade

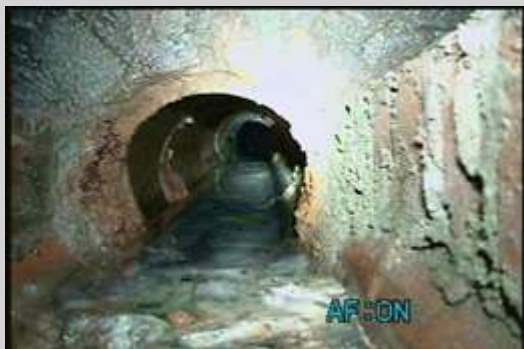
6 O'Clock Inflow

Invert Depth: 7.91 (ft.) Flow Characteristics: **Slow**

Connects To: **Dead End**

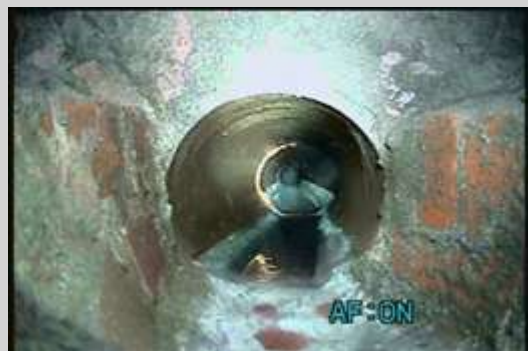
9 O'Clock Inflow

Invert Depth: **7.84** (ft.) Flow Characteristics: **Fast**

Infiltration: **None** Pipe Seal Cond: **Unknown**
